Canadian M113A1 Armoured Recovery Vehicle , Light - European Pattern

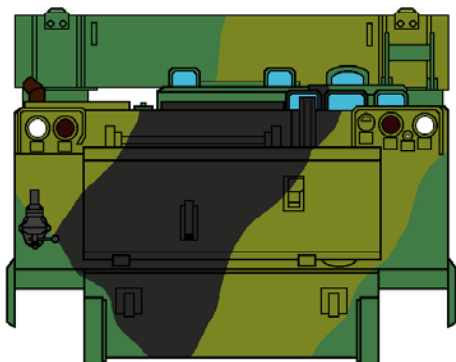
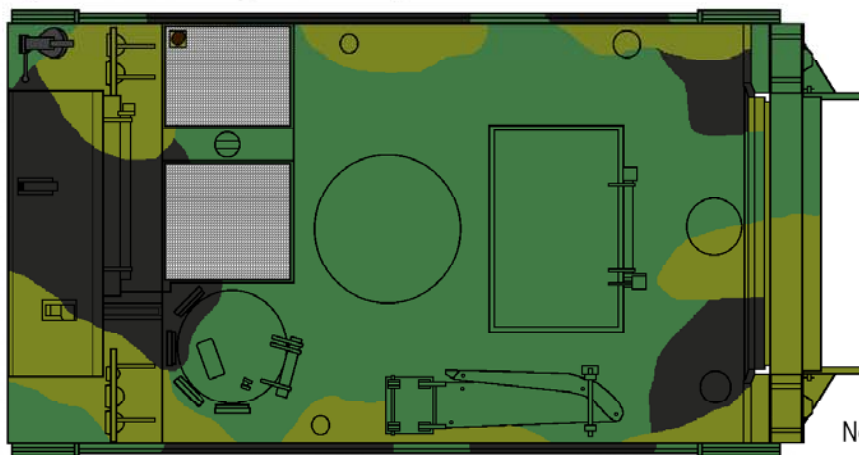
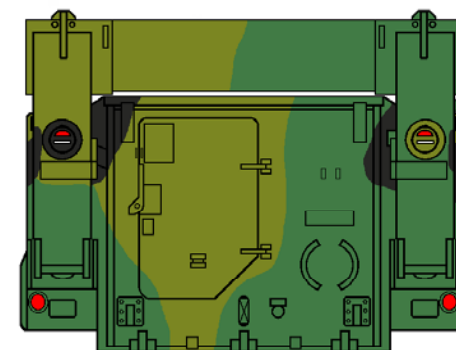
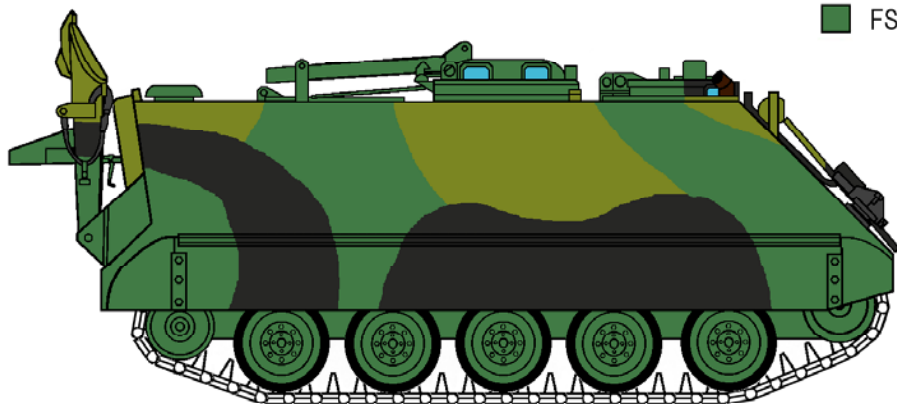
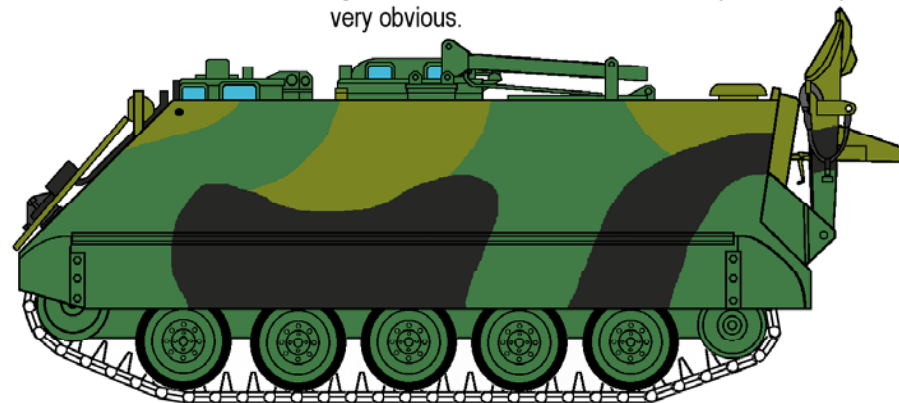
This pattern is the official scheme as used by 4 Canadian Mechanized Brigade Group in Germany from 1969. For winter the black was white-washed.

- FS 36081 Black
- FS340098 Khaki Drab
- FS34172 Green

Note: this is a pattern only, showing new paint colours. Every vehicle could, and usually did, have a variation in pattern from trivial to major. All three colours faded very quickly and were drastically altered by dirt and dust. The older and more faded the green became, the more it tinted blue. The khaki merely lightened and the black faded. Touch-ups were frequent and very obvious.
